Name Of Dam: LAKE BRITTLE DAM

Location: FAUQUIER COUNTY

Inventory Number: 06122

# PHASE I INSPECTION REPORT NATIONAL DAM SAFETY PROGRAM

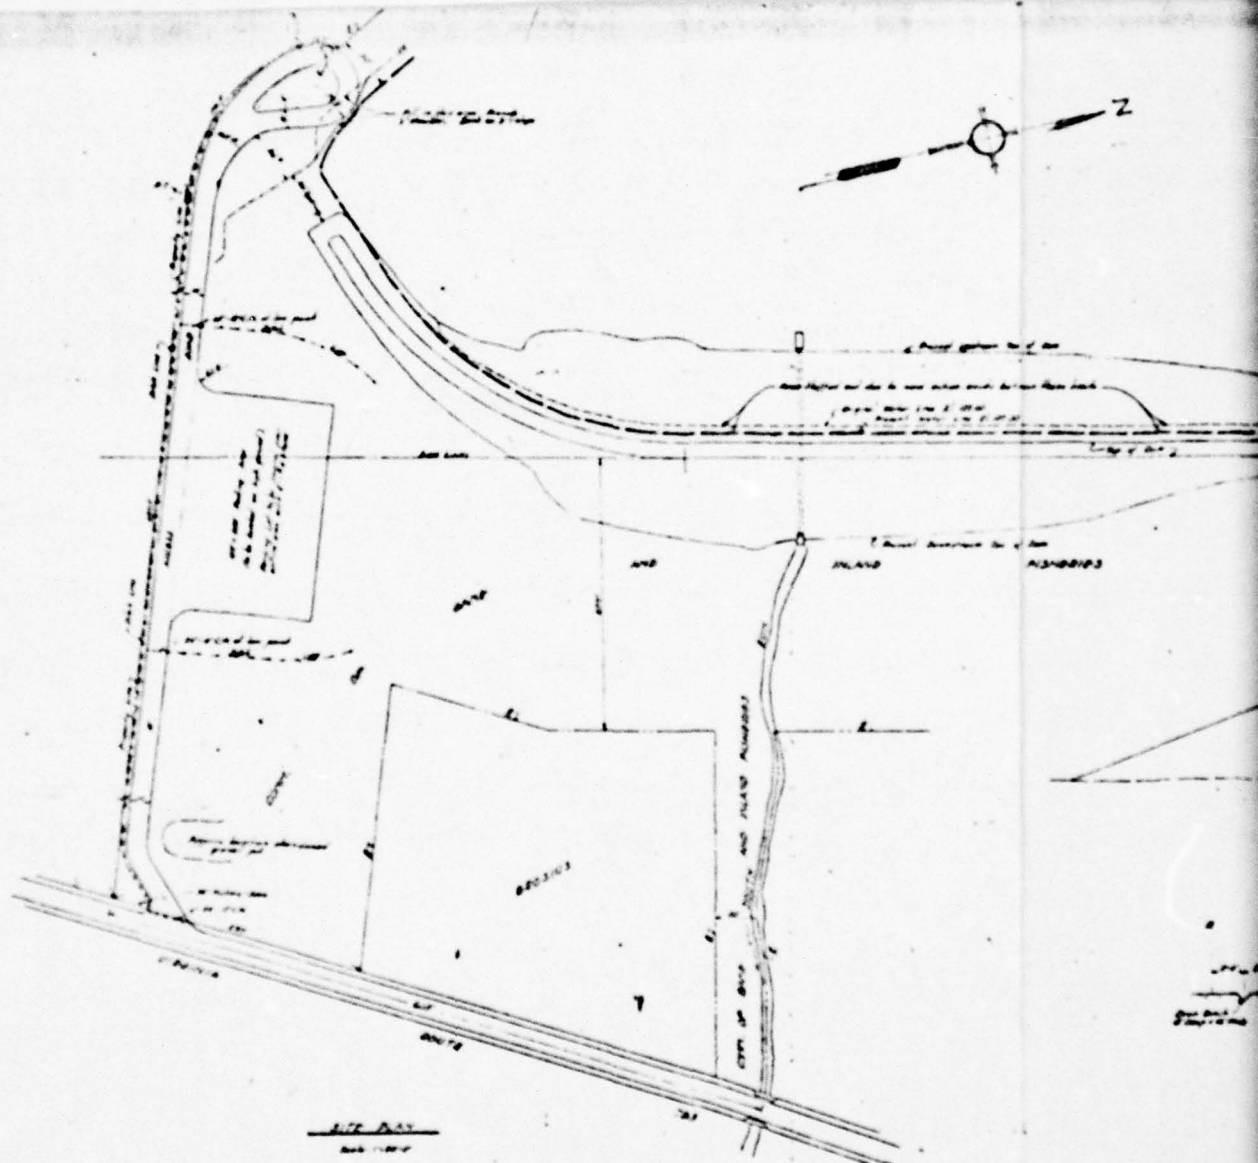
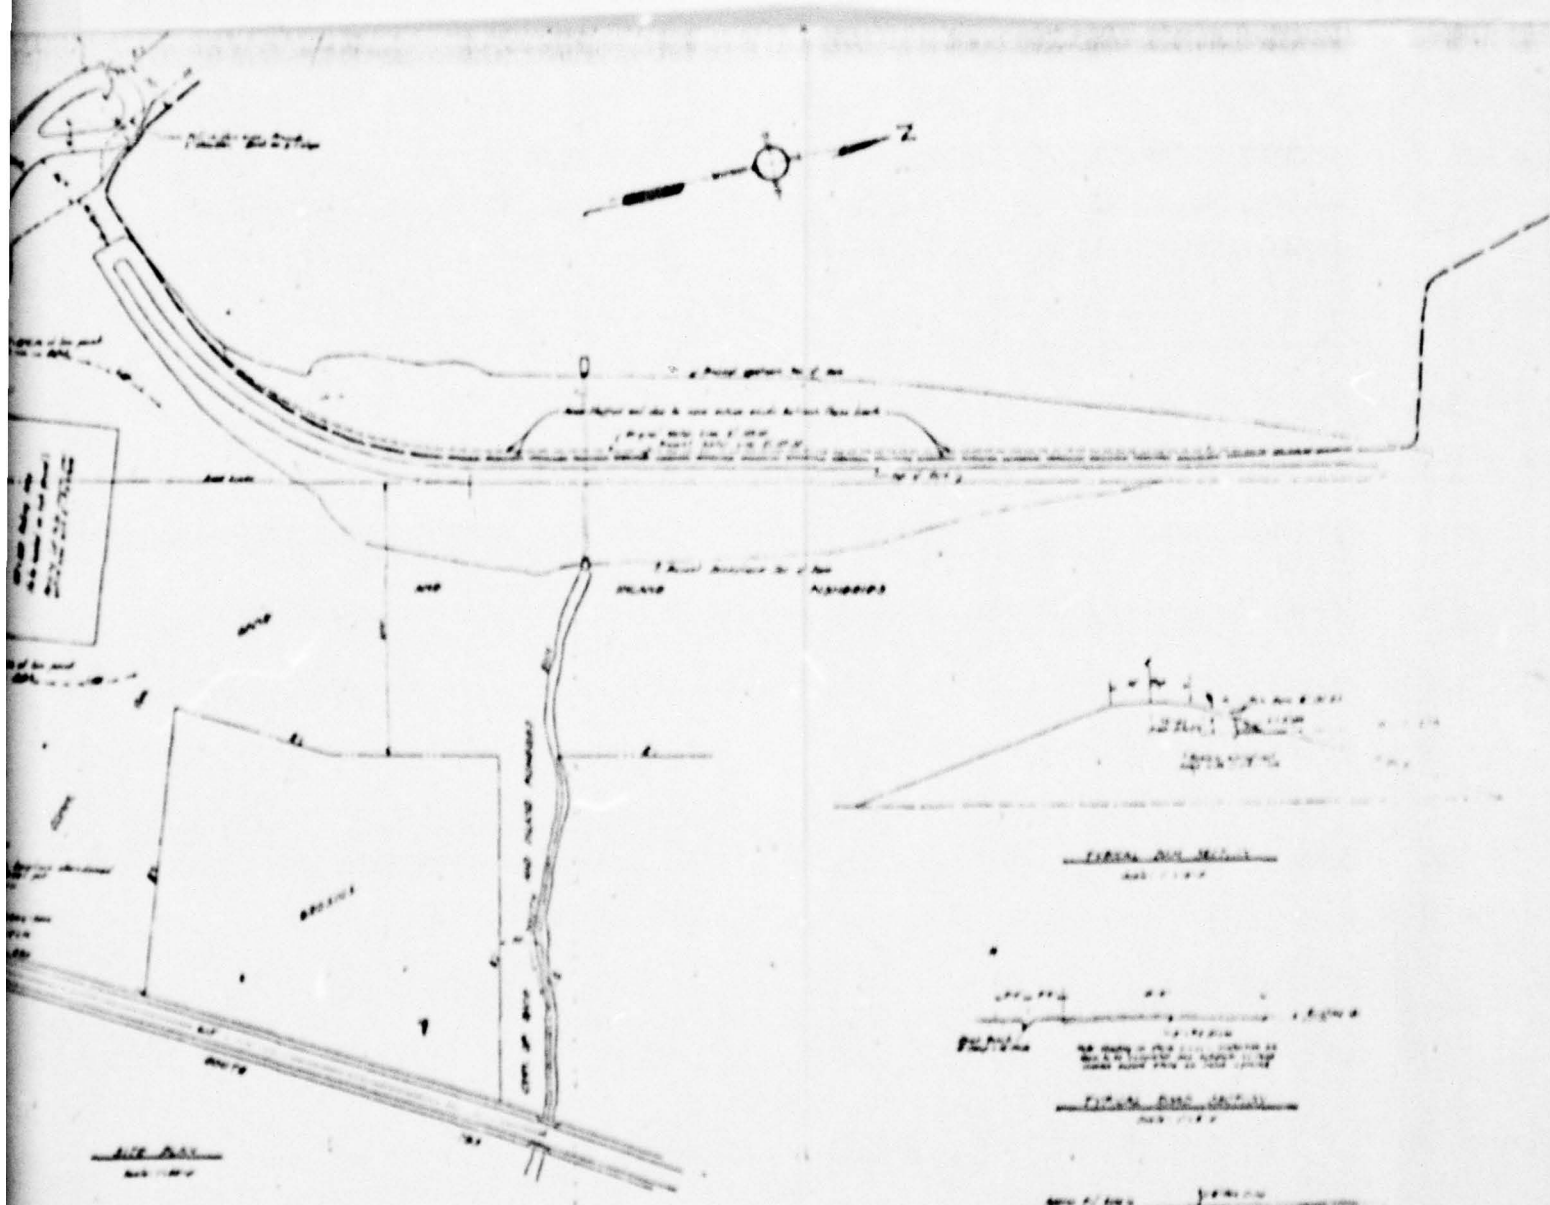
PLATE IV

b. A 1955 contract drawing by Perrow & Brockenbrough for the construction of an access road to the dam. The drawing also includes repair and riprapping of the upstream slope of the dam embankment (Appendix I, Plate IV).
